# DIAL

## Diagnostic Instrumentation & Analysis Laboratory

---

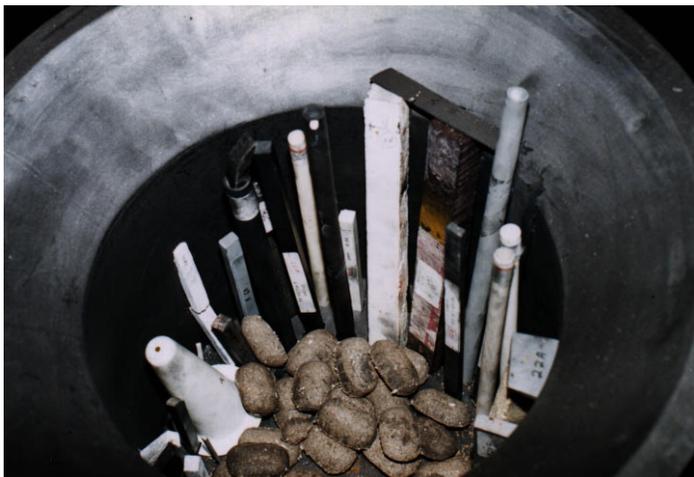
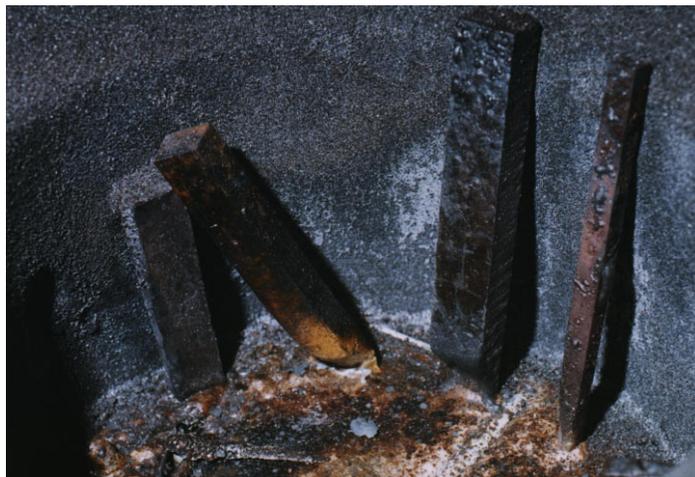
There were only a small number of the refractory samples that survived either test, as can be seen in the before and after photographs of the samples inside the crucible. For the first test, aluminum nitride, high chromium fused cast refractories and a silicon nitride sample survived. Only high chromium and one aluminum nitride sample survived the second test.

The 33 refractory samples were mounted inside a graphite crucible in a way that allowed them to be partially submerged in the molten glass for testing of below and above as well as at the critical melt line. A composition which simulated a typical LLMW was chosen by WSRC as a feed material for producing the melt. The study was comprised of two separate tests. The first test was a multiple cycle test in which the "waste material" and refractory samples were alternately heated and allowed to rapidly cool to near ambient temperature. During the heating cycle the waste material was held in a molten state for approximately four hours. The second test was a continuous operation test. A new crucible
